PRELIMINARY INSPECTION  
OF ST. MICHAEL'S CHURCH  
CLERIHAN, CLONMEL, CO. TIPPERARY  
PROTECTED STRUCTURE REF. NO. S.141  
SUMMARY REPORT

MARCH 2019

**PRELIMINARY INSPECTION OF ST. MICHAEL'S CHURCH  
CLERIHAN, CLONMEL  
PROTECTED STRUCTURE NO. S.141**

**SUMMARY REPORT**

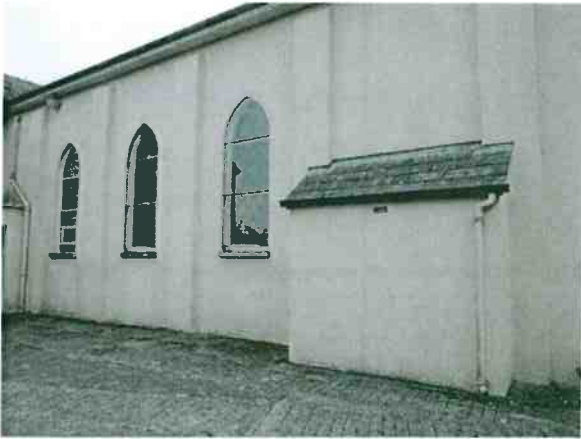
High Paving Level on North Side

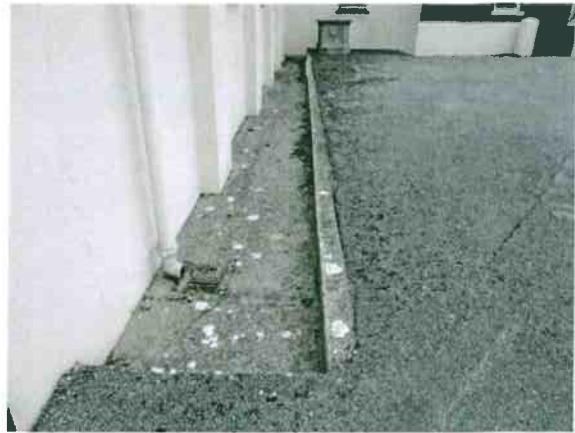
Along the South side a lower path/channel edged with a low retaining wall was provided. That reduced the risk of damp penetration but means that the Lobby is approached by steps and the channel is below the adjoining macadam.

Channel on South Side

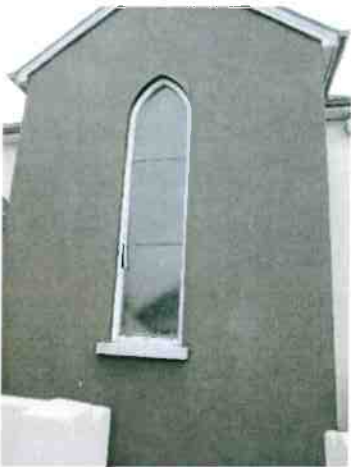
- The windows to the Lobbys/Stairwells are of timber, single glazed.  
They are in very poor condition and need to be replaced.  
The stained-glass windows in the Nave appear in good condition. The frames will need preparation, repair and repainting.
- The storm glazing will need to be refitted or replaced to allow improved ventilation.

Lobby Windows Poor

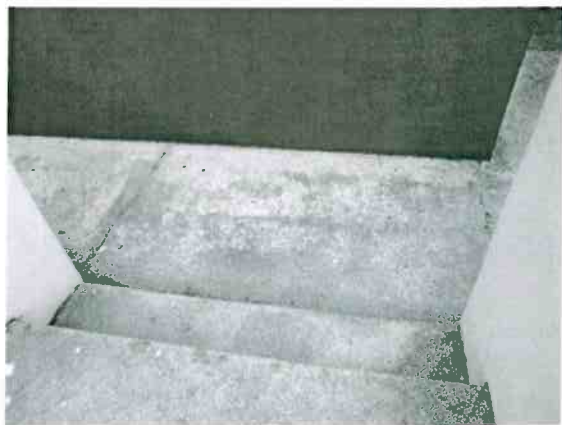
Steps to Doorway

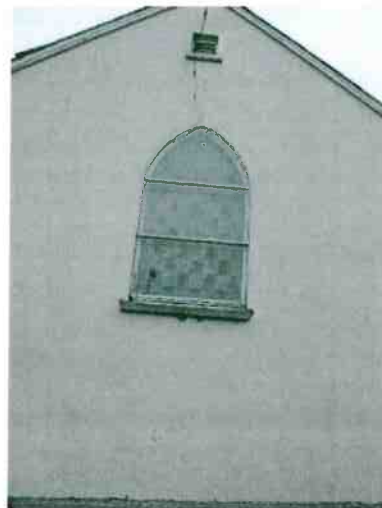
Trailing cable

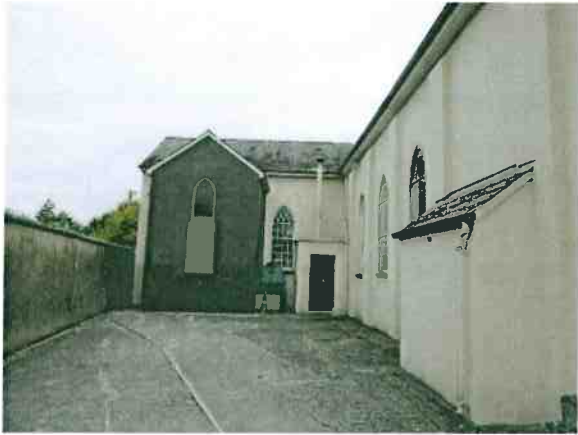
- While the line of the main roof looks reasonable in most areas, there is a very significant dip in the ridge of the North Transept. That will need to be rectified in the course of the Works.

- There is a lean-to slated roof over the Confessional where it projects beyond the North wall of the Nave.
- The flat roofs over the Lobbys and the Sacristy and Ancillary Areas, the Boiler House and the Store, appear to be of concrete and do not appear to be insulated.

Visible Deflection in Roof of North Transept  
Slating Moderate Concrete Flat roofs may be  
uninsulated

As part of any Remedial Work we recommend that they be treated, insulated and covered with a durable membrane system.

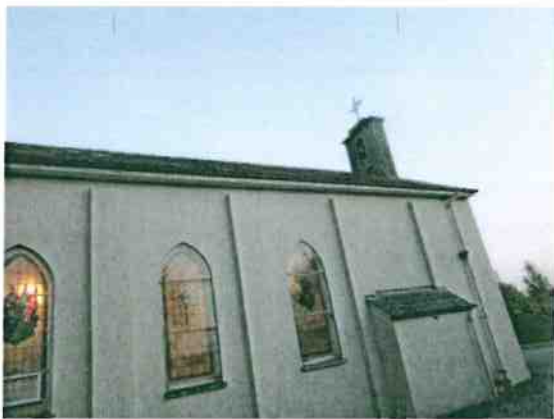
- Slating looks poor on the North slope of the Nave and on the North Transept. Elsewhere it appears moderate.
- All of the valleys are leaking and will need to be stripped back, re-formed and re-lined.

Slating looks poor on North slope

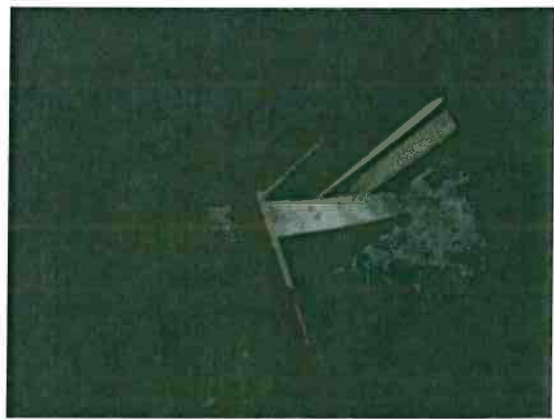
- Attic insulation is minimal and is poor.
- Woodworm is evident in roof timbers.
- It is also evident that the roof is not original and might be about 60 years old. (The walls have been built up at the gables and the sides and there is sarking felt under the battens).

Walls built up in blockwork

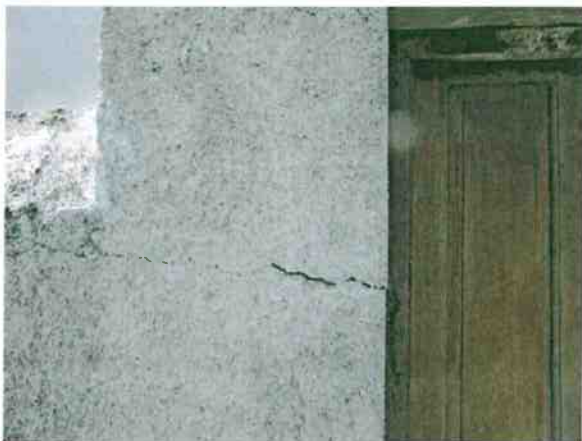
Boundary Wall needs repair

The screen wall and enclosure to Tower, on the roadside boundary of that yard needs to be repaired, capped and re-rendered or reduced in height, capped and fitted with a railing. The access door and frame are in poor condition and should be replaced.

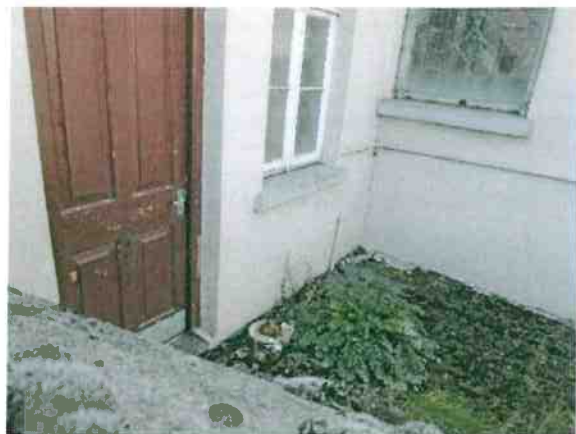
External doorset to Sacristy poor  
Yard needs to be cleaned and surfaced

The enclosed yard area in the North East corner outside the Sacristy needs to be thoroughly cleaned out, drained and surfaced and edged with drainage channel.

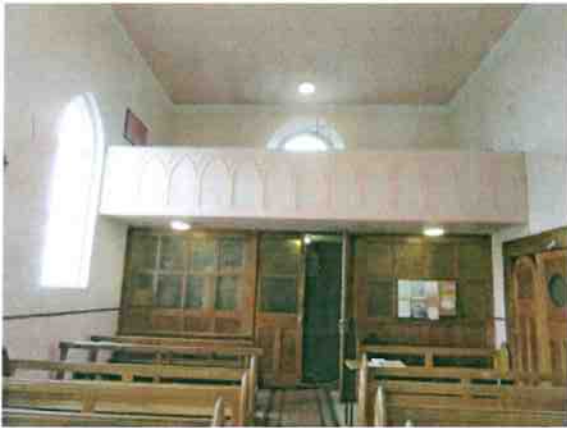
Repositioning of inner entrance screen should be considered

- Inner Entrance Doors and frames are of hardwood with glazed upper panels.
- Other internal doors and frames are panelled doors in painted timber.
- The inner Entrance Screen would be repositioned and altered/extended to suit its new position.

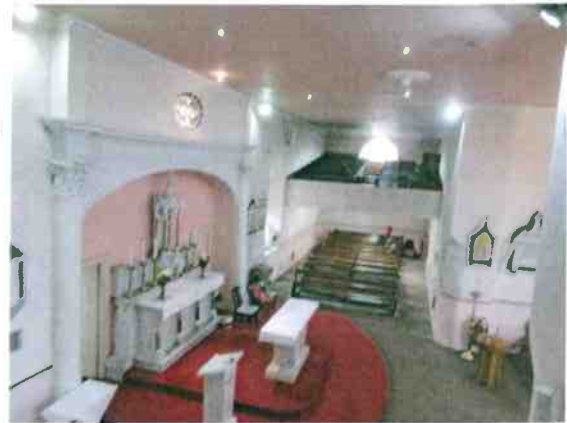
- There is significant distortion of the Reredos, at high level, where the upper section has deflected and appears to have moved forward. It will need to be secured in position as part of the Works.

Deflection in Recess evident

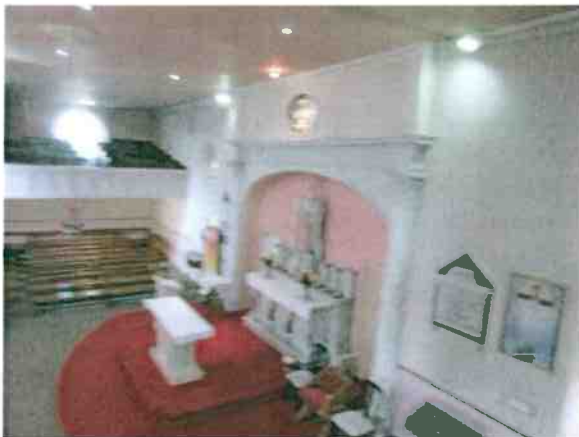
Trailing cables on Choir Gallery

- The Electrical Installation needs substantial upgrading. Recommended Works include re-wiring to serve new Distribution, Lighting, Power, Emergency Lighting, Fire Detection and Alarm System, Intruder Alarm, External Lighting etc. Automation of some doors will also be included.

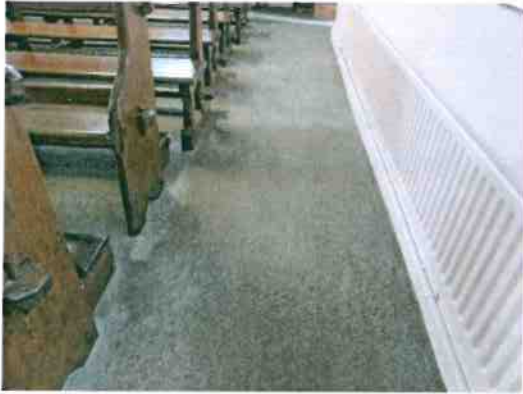
Floors could be damp under carpet

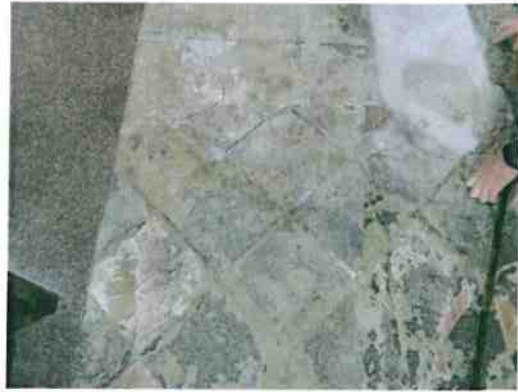
Old tiled floor

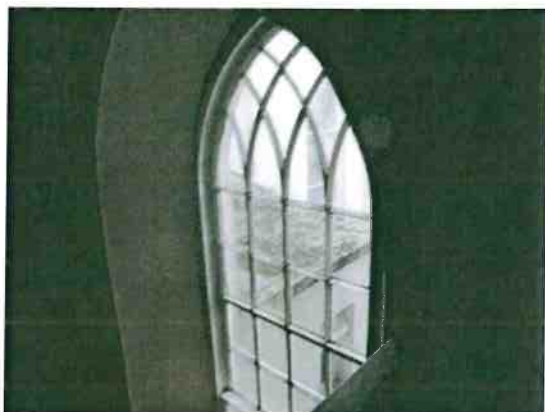
- The window in the West wall of the North transept appears original and will need to be overhauled and repaired.
- The other windows on the Transepts are mainly stained glass in timber and the framing needs some repair.
- External doors are of hardwood.  
The Main Entrance doors need to be replaced or substantially remade and fitted with draught seals and a new threshold detail.  
Other doors need overhaul and need to be fitted with draught seals.

Window to be overhauled and retained

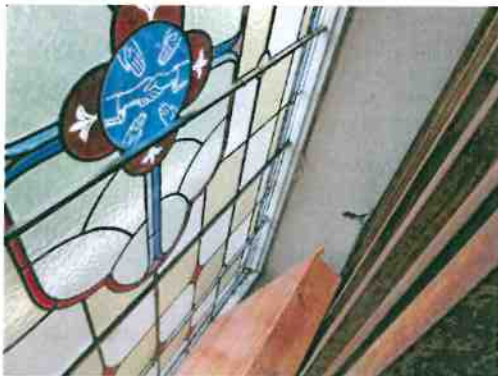
Stained glass needs cleaning  
Some frames need repairing and replacing  
Storm glazing needs to be considered

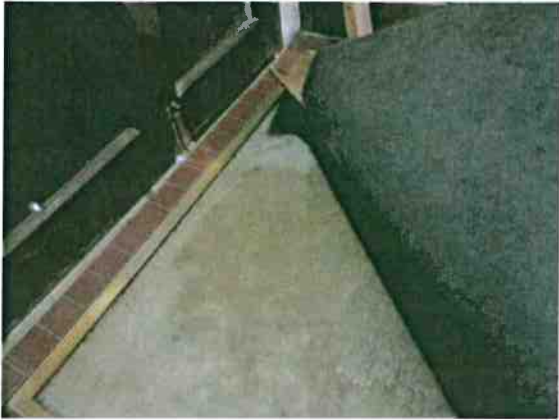
- The concrete floor at the Main Entrance is damp. This may be the result of a poor threshold detail and poorly fitting doors.  
There are old tiles on the floors of the Stairwell and Store on either side.

Front Door in poor condition  
Rain getting in also

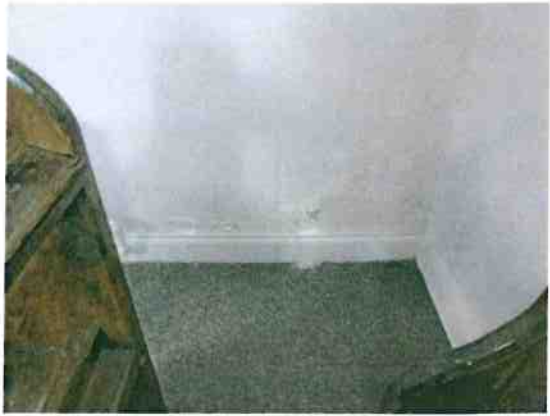
Dampness in walls

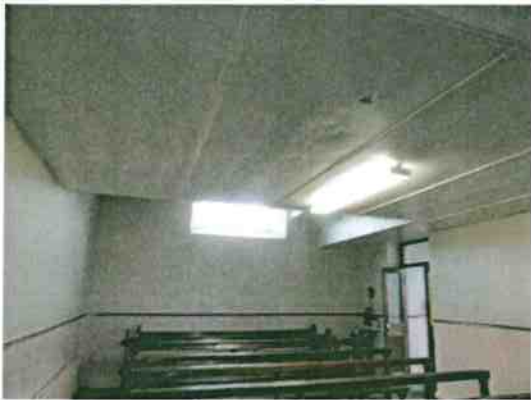
- The Balustrading to each Gallery will need to be raised or protected by a glazed screen to act as guarding.
- Soffits to Galleries appear to comprise hardboard. They need to be removed and replaced with fireline slabbing.

Soffits to Galleries to be replaced

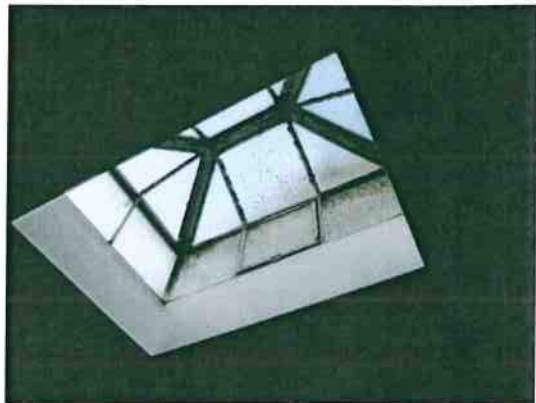
The Lantern Light over the Sacristy needs repair/overhaul and re-glazing or replacement.

Lantern light in Sacristy

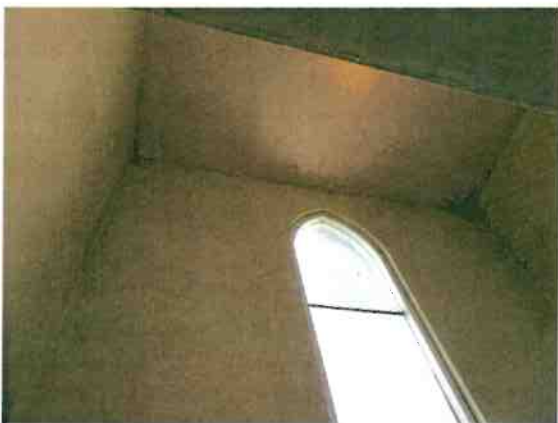
Dampness evident

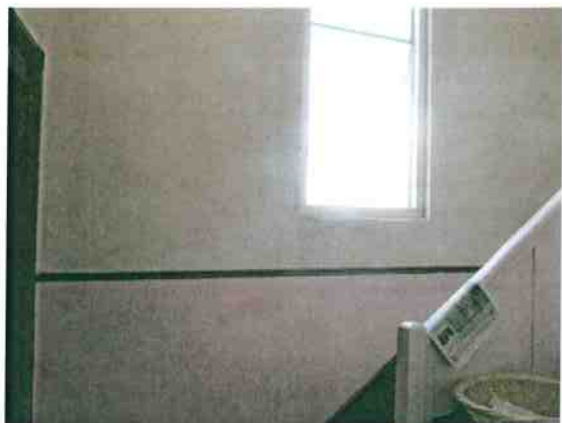
Poor window in Lobby/Stairwell
